# Cost-Effective Detection and Repair of Moisture Damage in Pavements

## *Evaluating existing non-destructive methods in order to detect stripping and moisture-induced damage in pavements*

Highlight | Jan. 2019

Project No. 18PLSU15

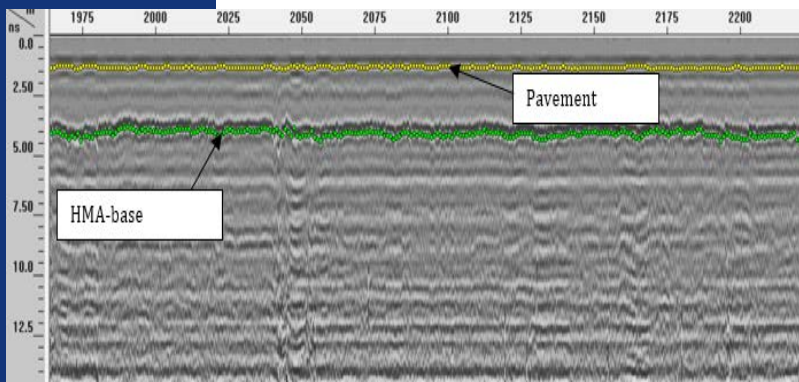
**Figure 1. GPR data scan of an asphalt pavement**

during pavement preservation activities, which may result in loss of state funds due to unsatisfactory performance after repair. Ground Penetrating Radar (GPR) and Falling Weight Deflectometer are nondestructive evaluation (NDE) techniques, which have been applied to assess as-built conditions and to evaluate damage and deterioration that develops over time. They can also be used to measure layer thicknesses and to detect moisture-induced damage in pavements. TxDOT investigated the ability of GPR to detect stripping in the asphalt pavement layers. Researchers in Texas were able to detect stripping in the asphalt pavement layers using GPR where the deterioration was at a moderate to severe level. The study found that asphalt pavement sections with stripping had higher moisture contents or higher air voids, or both; which resulted in an anomalous change in the dielectric constants of the stripped layers. The authors also noted that intermittent negative peaks within the surface layer in a GPR scan is typically an indication of the presence of stripping in the asphalt pavement layers.

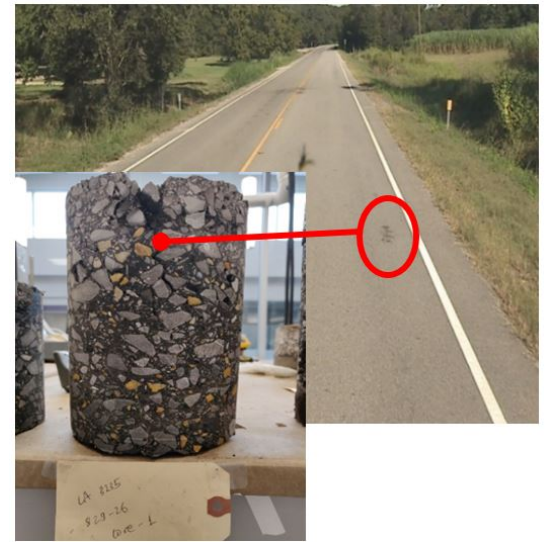
**Figure 2. Successful identification of top-down cracking using digital image analysis**

Guidelines were developed to identify top-down cracking (TDC) in flexible pavements using digital image analysis and the characteristics of these cracks. Past studies indicated that the time after construction of the pavement and location of the cracks are key parameters to identify top-down cracking. The cracks were reported to appear on the wheel path or at the outer edge of the wheel path typically within 3 to 8 years of construction. In-service pavement sections were selected for analysis based on the parameters identified from the literature and computer-vision techniques were employed to investigate the geometric characteristics of these cracks. Based on the results of the analysis, the average crack width was observed to be 3 to 7 mm. With respect to the orientation of the crack, the cracks segments were mostly longitudinal with typical deviation of 20 degrees. The orientation and intensity characteristics of top-down cracks were found as useful features in crack identification.
