Enhancing Evaluation of Wildlife Detection Systems

Monitoring wildlife and wildlife-vehicle collisions at wildlife crossings

Project No. 19SAUNM03

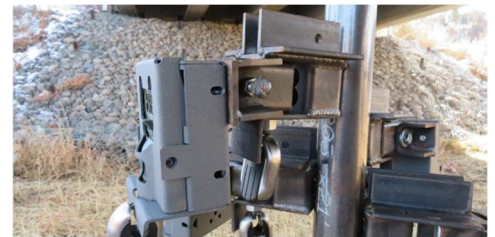
Figure 1. Camera mount.

crossings. Special mounting brackets were designed and fabricated to allow for the installation of monitoring equipment (Figure 1). Past road ecology research by the New Mexico Department of Transportation (NMDOT), Arizona Game and Fish Department (AZGFD), and New Mexico Department of Game and Fish (NMDGF) informed the design of our monitoring sites.

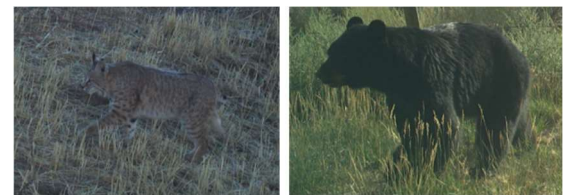
Figure 2. Bobcat and bear captured at the crossing site.

Over the seven months of study (mid-November 2019 to mid-June 2020), nearly 100,000 wildlife photos were captured consisting of 1,438 individual animals. Wildlife approaches and crossings were more frequent at the larger bridge. However, both crossings saw passage rates of approximately 80%, showing that the structures are effective in size and design. Detections primarily consisted of elk and deer, along with fewer sightings of bear, bobcat, coyote, foxes, and mountain lions (Figure 2). Elk predominated during December through March while deer predominated during May through June. Elk used the crossings most frequently between approximately 22:00-02:00 and 06:00-08:00. Crossings were predominately southbound in early winter and northbound in late winter and spring.
